National Transportation Safety Board Aviation Accident Final Report

Location:	Port Orange, FL	Accident Number:	ERA17FA074
Date & Time:	12/27/2016, 1756 EST	Registration:	N669WR
Aircraft:	INDEPENDENT TECHNOLOGIES INC EPIC LT	Aircraft Damage:	Substantial
Defining Event:	Loss of control in flight	Injuries:	2 Fatal
Flight Conducted Under:	Part 91: General Aviation - Personal

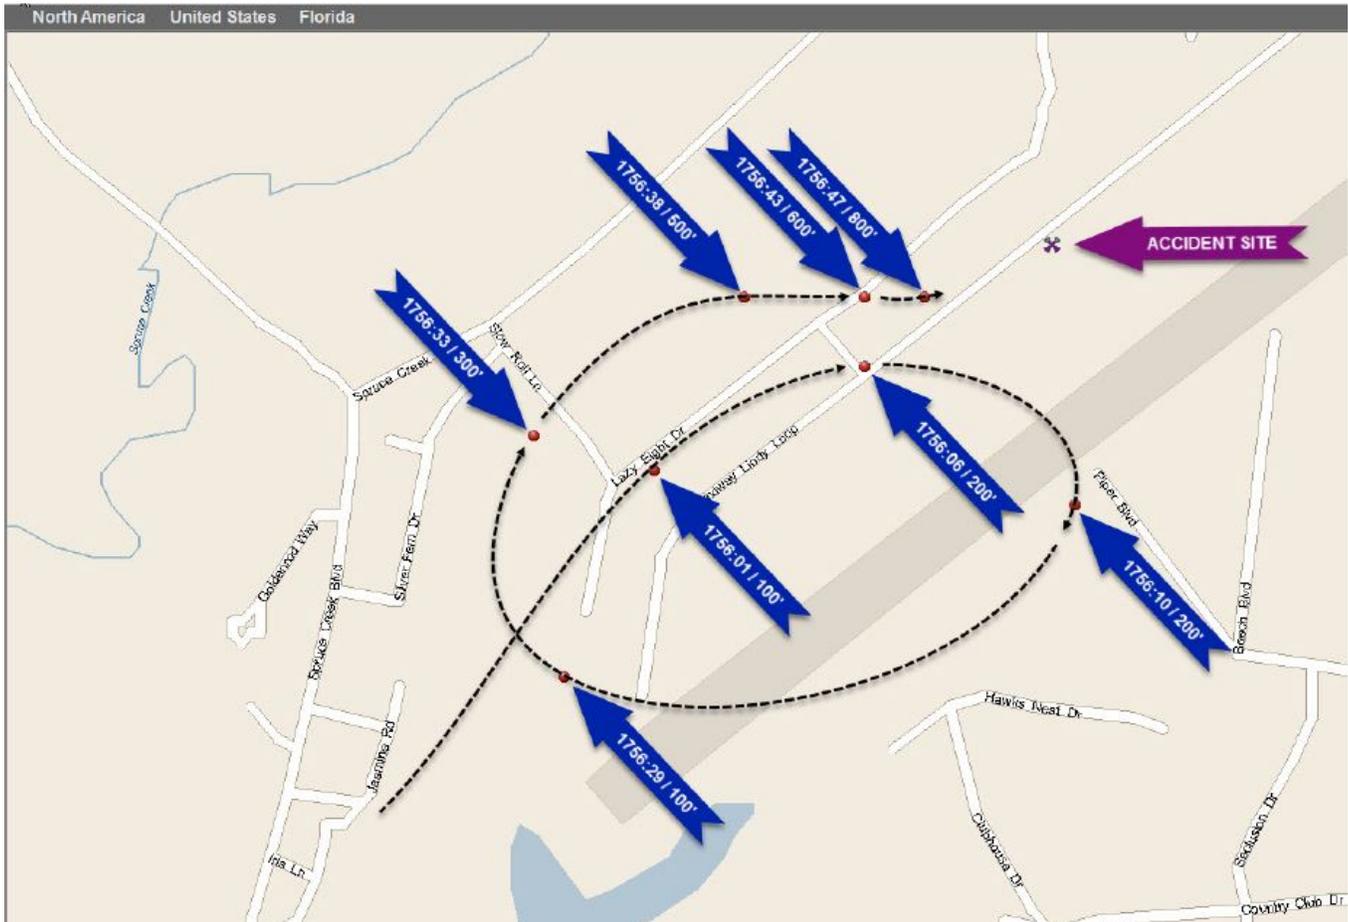
Figure 1. Radar Flight Track of Attempted Landing at 7FL6.

A review of radar data revealed that, during the final 46 seconds of flight, the airplane approached the airport on a northeasterly heading just north of the final approach course. At 1756:01, the airplane was abeam the runway numbers at an altitude of 100 ft mean sea level (msl) (76 ft above ground level) before it initiated a climbing right turn. During the turn, the airplane initially climbed to 200 ft msl then descended to 100 ft msl before climbing up to 300 ft. After completing a 360° turn, the airplane began to climb on a northeasterly heading. Over the next 14 seconds, the airplane climbed to 800 ft, while making a shallow turn to the right

followed by a turn to the left before the data ended at 1756:47. The last radar return was near-coincident with the location of the accident site (See figure 1).
